Manhole Inspection Summary

Manhole # S37Y1_010MH

Insp Date: **5/1/08 12:44 PM**

Location Address: **3801 2nd St.**

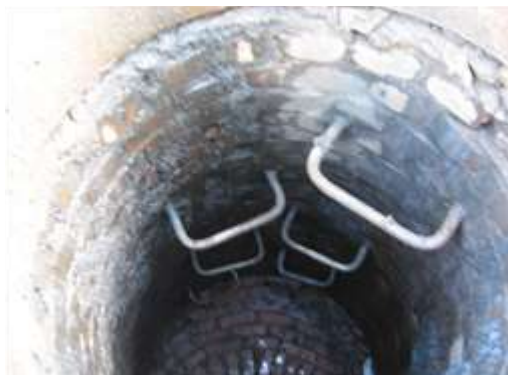
Steps Count: **6** Missing: **0** ☒ **Corroded**

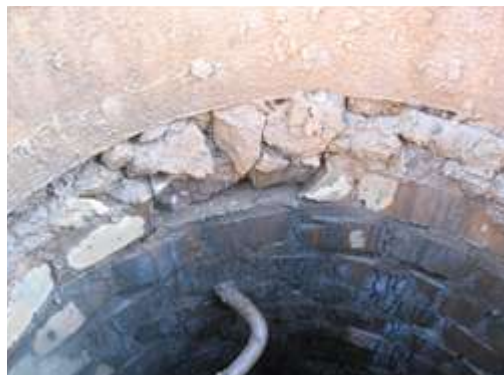
Defect 1

Condition: ☐ Sound ☐ Cracked ☐ Root Intrusion ☒ **Loose Brick** ☐ Deteriorated

Infiltration: ☐ None ☒ **Joint** ☐ Cracks ☐ Mortar ☐ Roots ☐ Wall

Chimney

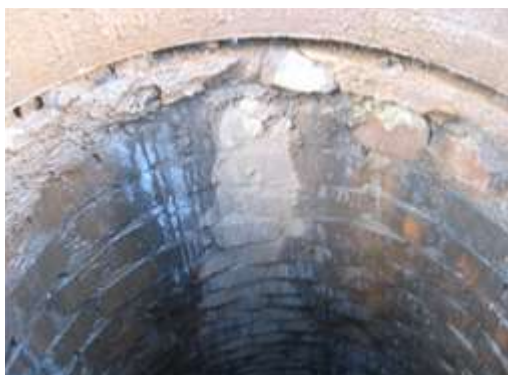
Defect 2

Infiltration: ☐ None ☐ Joint ☐ Cracks ☐ Mortar ☐ Roots ☒ **Wall**

Infiltration

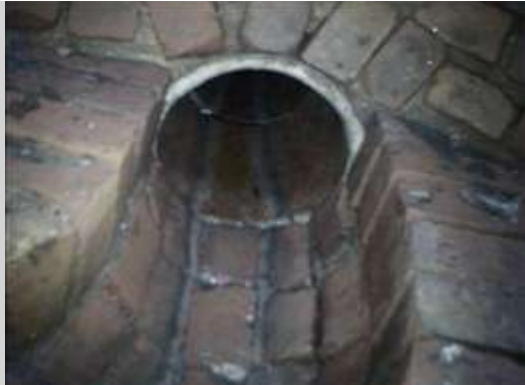
12 O'Clock Outflow

8 in. Circular Gravity Sewer
Pipe Out @ 12 O'Clock

Pipe Height: **10.8** (in.) Rod and Bar (Angled)
Pipe Material: **Clay** ☐ Pipe Lined
Invert Depth: **10.28** (ft.) Flow Characteristics: **Fast**
Deposits: ☒ None ☐ **Mud** ☐ **Grassy** ☐ Debris ☐ Grease
Silt Depth: (in.) Deposits Extent:
Infiltration: **None** Pipe Seal Cond: **Sound**

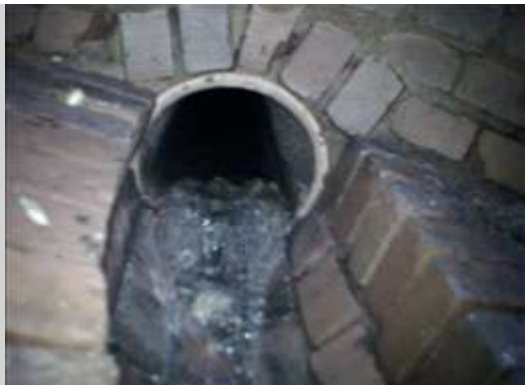
9 O'Clock Inflow

8 in. Circular Gravity Sewer
Pipe In @ 9 O'Clock

Pipe Height: **10.8** (in.) Rod and Bar (Angled)
Pipe Material: **Clay** ☐ Pipe Lined
Invert Depth: **9.98** (ft.) Flow Characteristics: **Fast**
Deposits: ☐ None ☒ **Mud** ☒ **Grassy** ☐ Debris ☐ Grease
Silt Depth: **1** (in.) Deposits Extent: **Light**
Infiltration: **None** Pipe Seal Cond: **Sound**
